Hole in One

A modified conventional septic system with drainfield chambers makes the most of restrictive conditions on a golf course

By **Scottie Dayton**

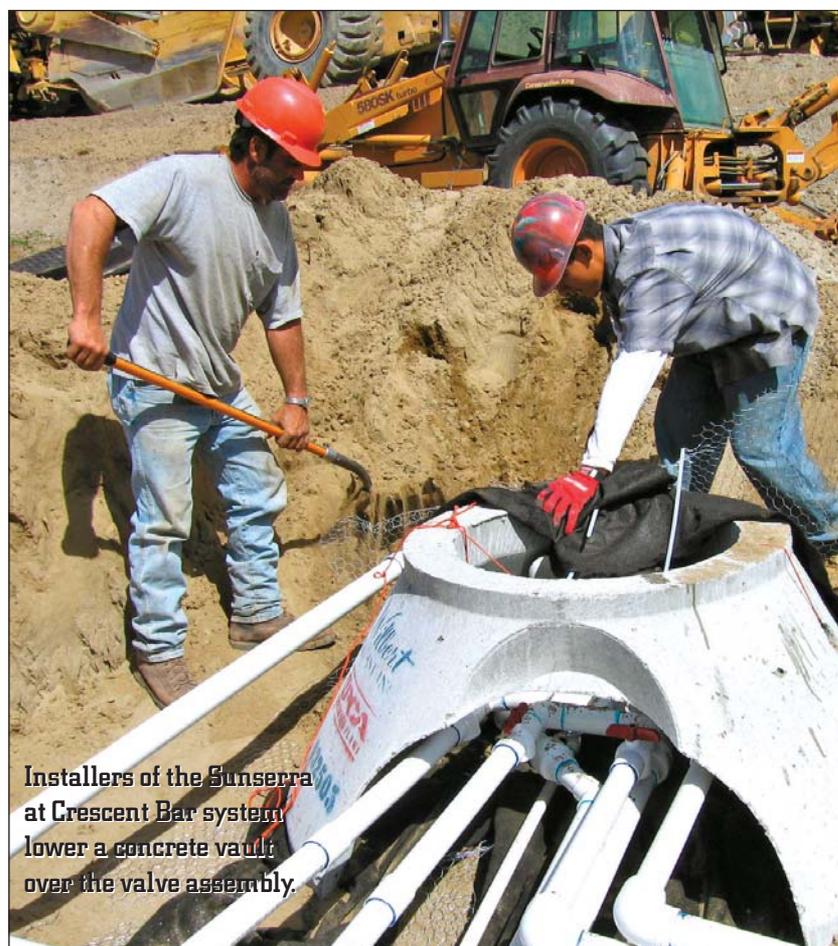
Installers of the Sunserra at Crescent Bar system lower a concrete vault over the valve assembly.

The switching gear and distribution vaults were installed on the golf course. Because lids on the fairways are a sensitive issue, Glassco took a valve assembly

to Scott Erickson at Wilbert to see if he had a vault with a small lid that would enclose it. He did.

Wilbert constructed a mold of the conical vault that was open at the bottom so Freese could build the distribution piping, then lower the vault over the top of the valve assembly. “Should a valve fail, we can excavate around the vault, lift it off and repair the valve,” he says.

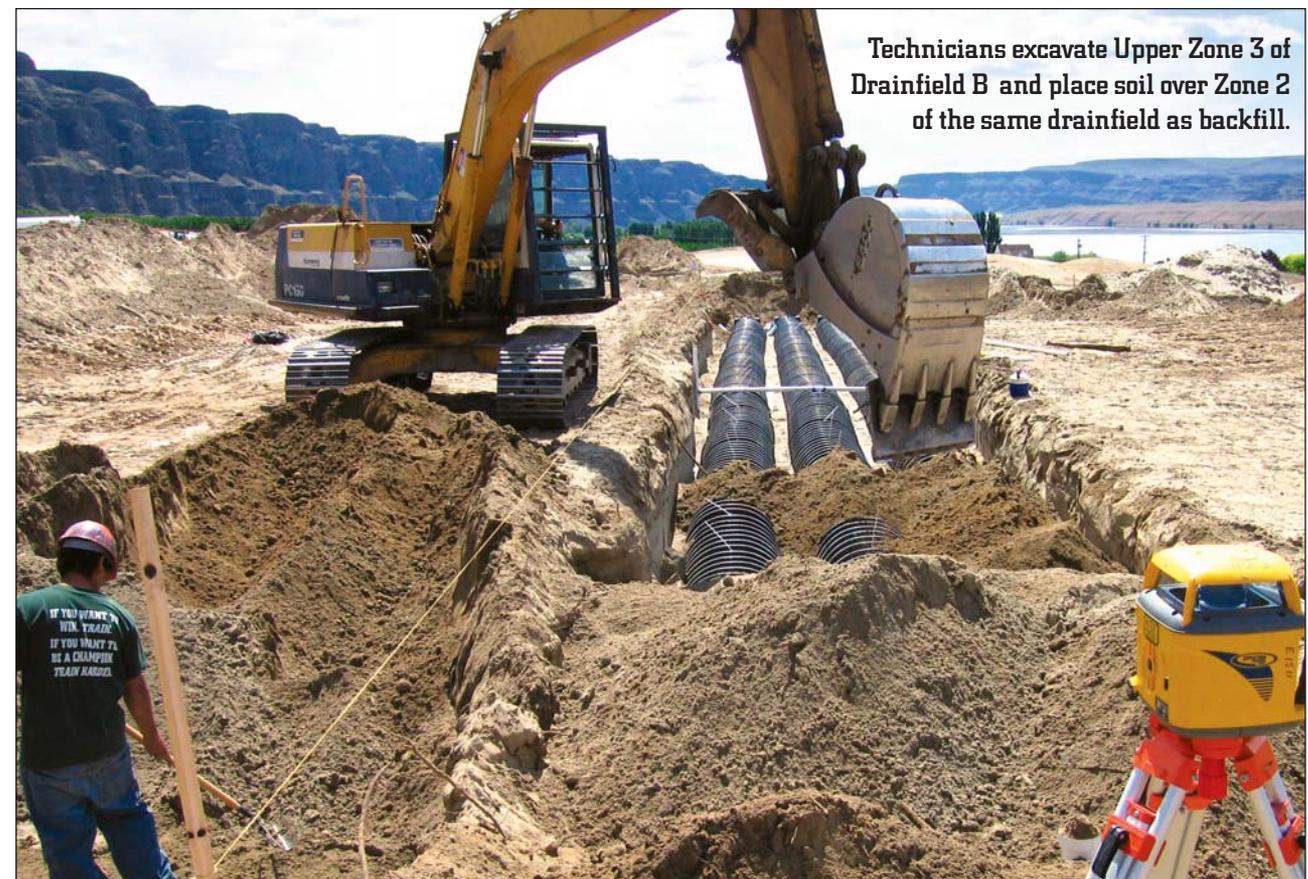
Technicians excavate Upper Zone 3 of Drainfield B and place soil over Zone 2 of the same drainfield as backfill.

Each drainfield – the average footprint is 40 by 240 feet – has six, time-dosed zones. “Orenco prefers the distribution valve installed at the pump chamber to prevent air from entering the system, but that leaves the line to the drainfield full and susceptible to freezing,” says Glassco. “The drainfields are 36 inches deep, but in places the transport lines are much shallower, with the golf course’s 16-inch deep irrigation system below and above them.”

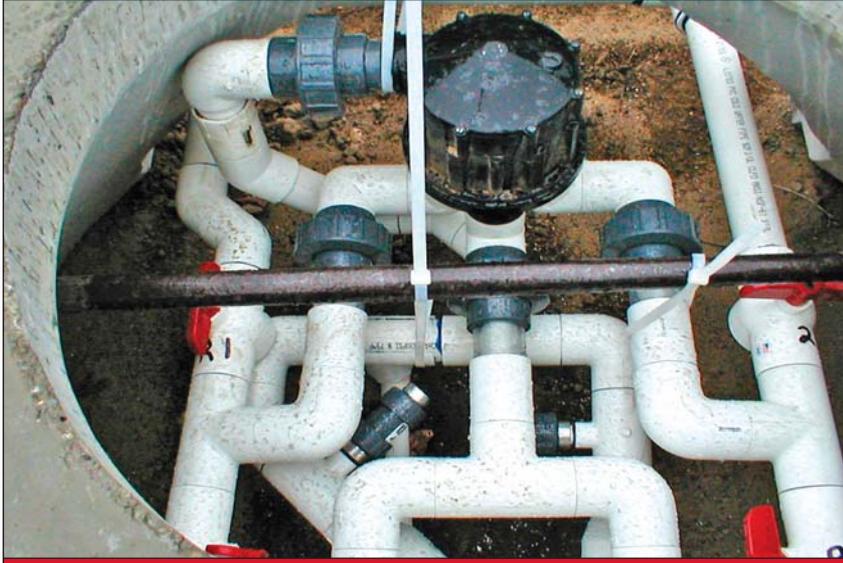
A view inside the vault shows the distributing valve (black) at the top.

Glassco mounted the distribution and check valves at the drainfield and supplied them with two transport lines, one for each pump in the chamber. When a pump shuts off, the check valve opens, and air enters the line. “A line longer than 500 feet drains back into the chamber

through the pump within three and a half minutes,” says Glassco. The manifold drains effluent back into the drainfield from the distribution valve.
