Close Quarters

An aerobic treatment unit and drainfield chambers help designers make the most of a site's restrictive conditions

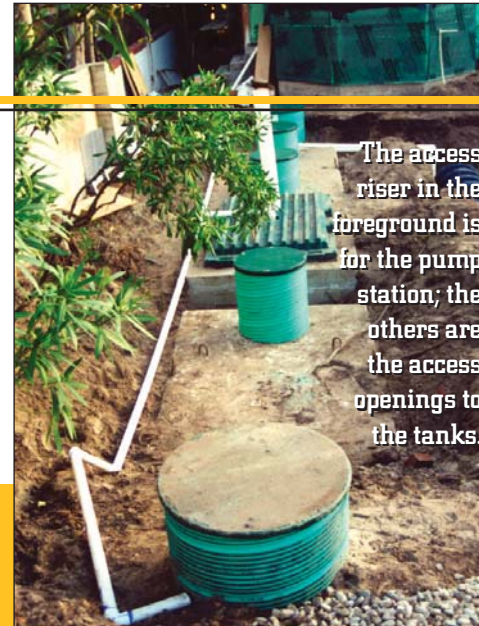
The access riser in the foreground is for the pump station; the others are the access openings to the tanks.

Yaroslaski sized the system to handle 600 gpd. The heart of the system is a two-compartment, 2,500-gallon concrete pretreatment tank containing a Bio-Microbics 1.5 HiStrength fixed activated sludge treatment (FAST) unit.

A large box-like container suspended from the lid inside the tank contains media to which bacteria cling. Above ground under a poly box is the blower unit with a blower motor and air filter. The system also includes:

- 2,500-gallon dosing/surge tank with duplex pump system
- 24-inch-diameter, 30-inch-high pump basin with 2-inch discharge grommet, Biotube pump vault, and VeriComm telemetry monitoring system vault from Orenco Systems Inc., Sutherlin, Ore.
- Two 1/2 hp 2-inch alternating Grundfos sewage ejector pumps
- 20 high-capacity Infiltrator chambers from Infiltrator Systems Inc., Old Saybrook, Conn.

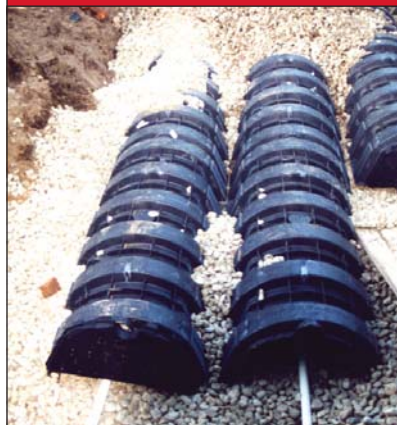
Partial installation of the chambers with gravel bed and pipes for dispersing the treated effluent.

surized dosing tank. Four times an hour, the pump activates, sucking the liquid through an effluent filter before it reaches the pump vault. High-head effluent pumps deliver the pretreated liquid to the zone valves for dispersing to two 410-square-foot leachfields. There it flows through washed sand and returns to the environment.

"I was concerned about the possibility of masking the sand if we used gravel in the leachfield," comments Yaroslaski. "The chambers eliminated the need for gravel, maintained the proper separation to groundwater, and offered the maximum internal volume per foot for increased surface area."

Excavated drainfield sand was dried on site, transported to waiting trucks by conveyor belt, then hauled to a landfill. The belt also brought in washed granule sand for tertiary treatment. The fiberglass FAST unit was installed in the 32,000-pound septic tank while it was still sitting on the road. The men carried in the chambers, drilled holes through the tops, and hung 1-inch PVC pipe to transport the effluent. They laid a filter fabric over the chambers to keep out dirt, covered that with a thin layer of gravel, then backfilled with native soil.

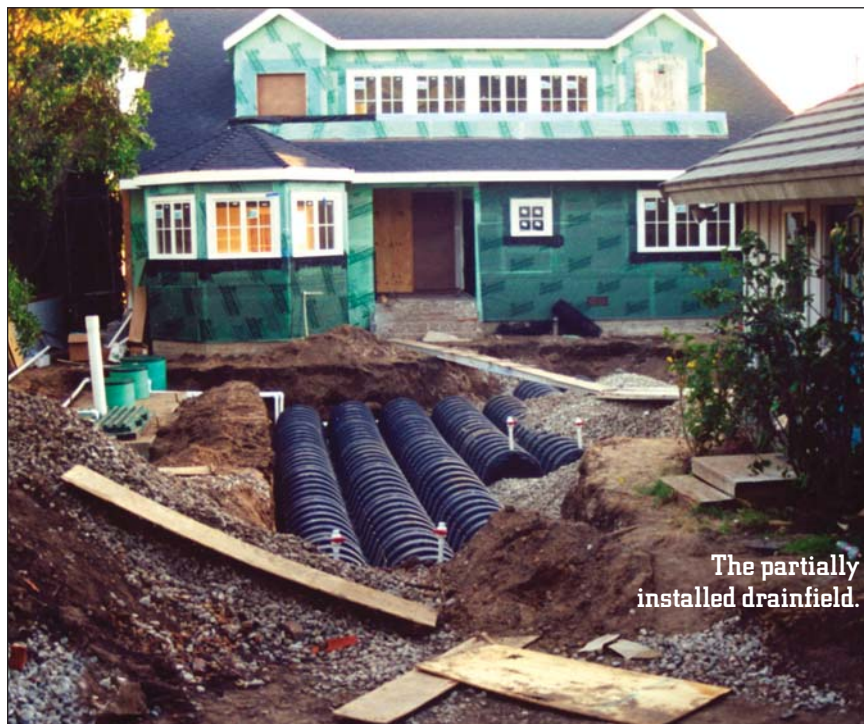
The partially installed drainfield.
